ARCHEOLOGICAL INVESTIGATIONS AT
THUNDERBIRD LODGE
CANYON DE CHELLY, ARIZONA

PETER J. McKENNA

SCOTT E. TRAVIS

SOUTHWEST CULTURAL RESOURCES CENTER PROFESSIONAL PAPERS
NUMBER 20

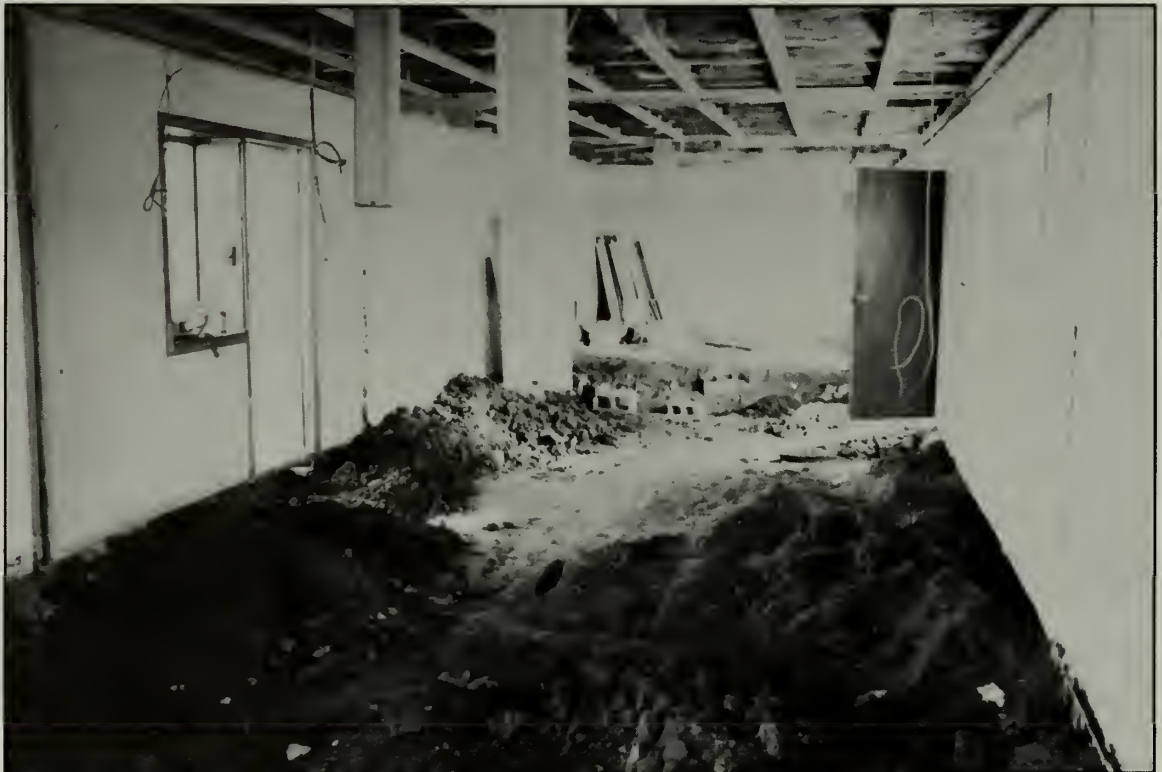
Figure 1.8 Interior of Building 14 after razing. Fill dirt is being added preparatory to pouring a concrete slab floor.

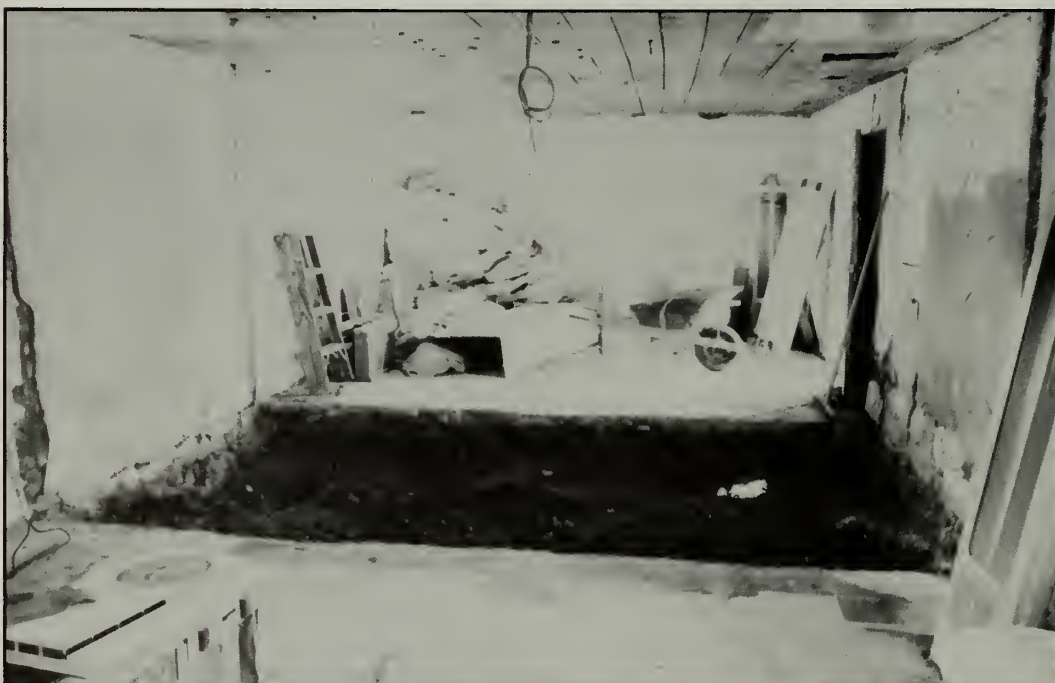
Figure 1.10 Interior of Building 15 after razing, showing removed central section of concrete floor.

The section of floor torn out, which was removed prior to any archeological examinations, measures 14 by 8.5 feet and averages just over 16 inches in depth. It revealed a segment of the structural foundations, a poorly defined foundation footing trench, and a relatively complex stratigraphy composed of construction and occupational debris (Figure 1.10).

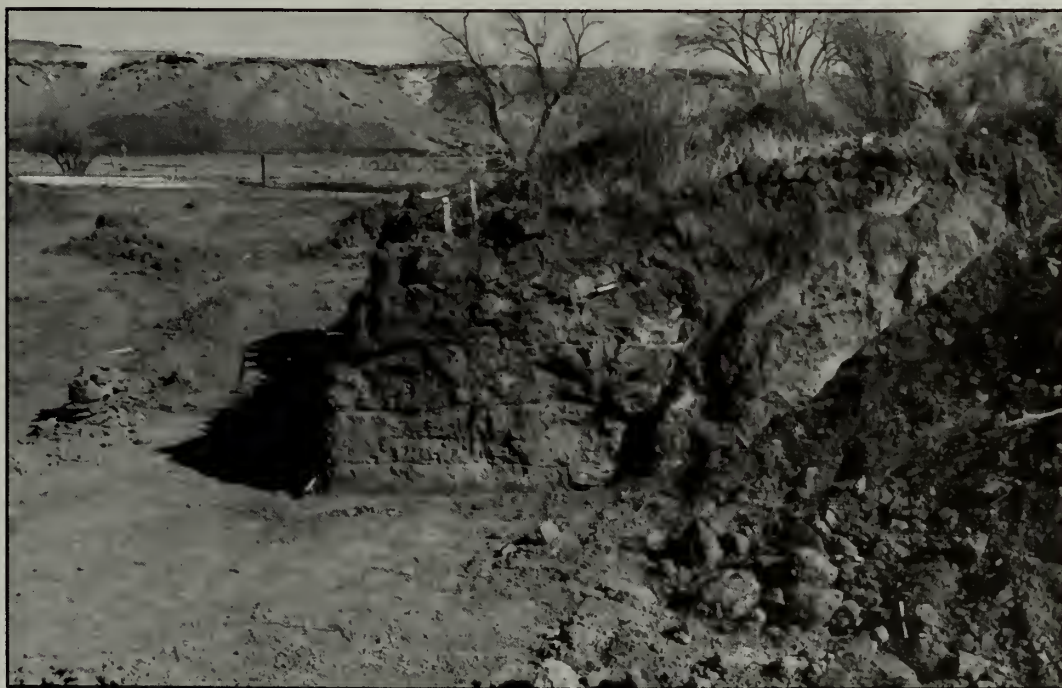
Figure 2.11. View of west profile showing stratigraphy.

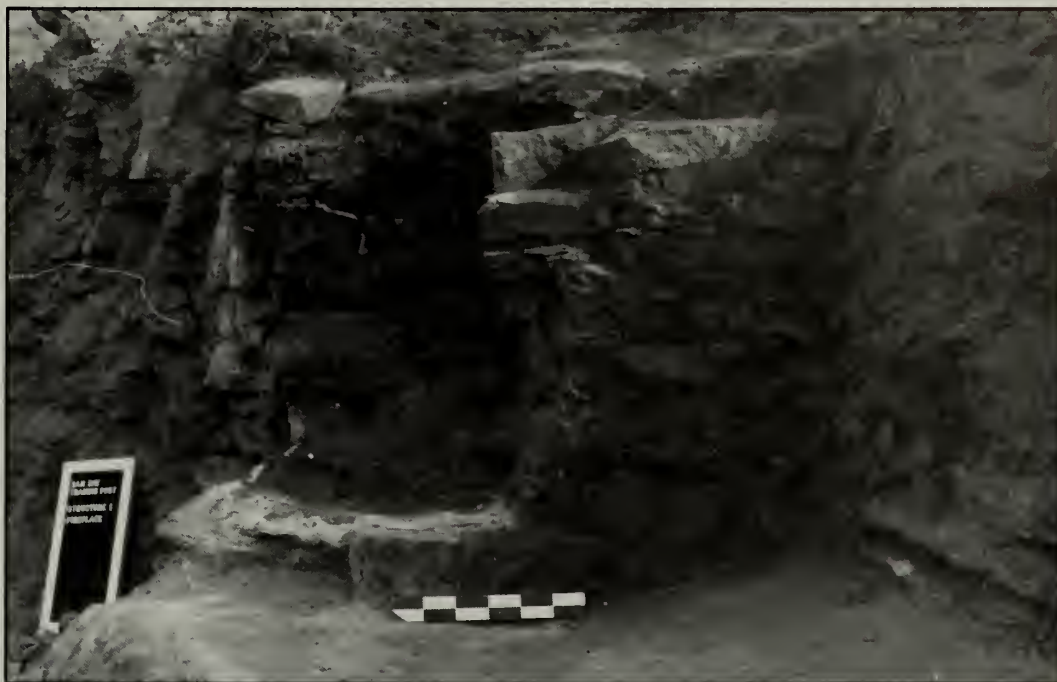
Figure 2.14 Detail of beehive-style masonry fireplace (30 cm scale to north).

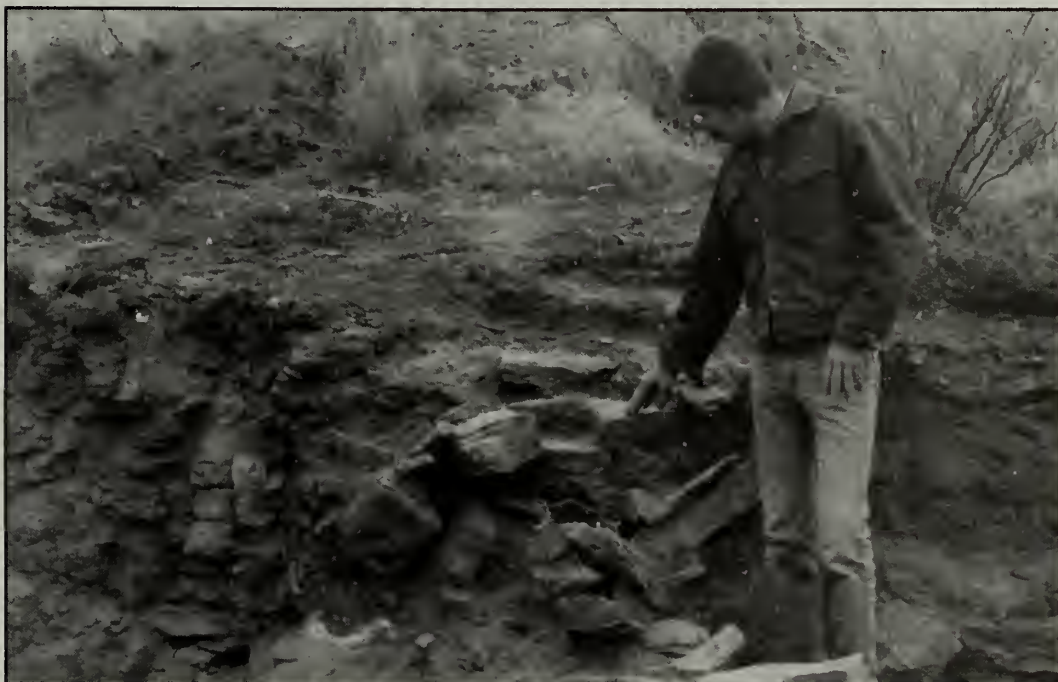
Figure 2.17 Collapsed fireplace. John Stein pointing to location of fireplace top beside mantel stone notch.
